A Boughey Pty Ltd at Collahuasi Mine - Chile

Ball Mill Failures

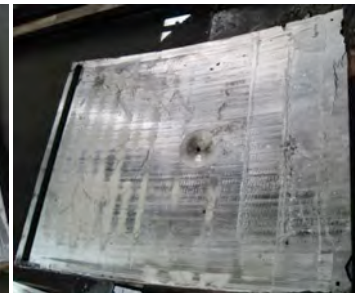
Damage to the main support bearing pads was evident on both the feed and discharge ends of the mill, with catastrophic failure of one pad observed on the discharge end bearing. There was a significant amount of cracking in the babbitt, most likely as a result of heat stress (see photos to the right).

The evidence from the failure mode assessment suggests that the failure was primarily the result of a breakdown of the lubricant film due to contamination. There was significant evidence of high levels of contamination in the oil sampling records.

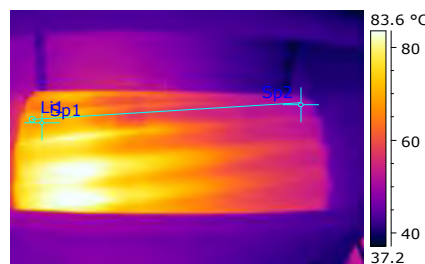
Temperature measurements (thermography) across the pinion face width indicated that the load was not evenly distributed, but rather concentrated towards one end of the pinion. Gear manufacturers typically recommend a maximum operational temperature differential to be less than 8°C. Recorded differential temperatures have been as high as 24°C across the pinion face width.

Apart from periodical temperature measurements using thermography, no monitoring of the gear temperature had been undertaken. The ball mill gearset lacked a continuous on-line monitoring system to provide good protection and timely feedback against sudden changes in operating conditions. A Boughey Pty Ltd highlighted this to Collahuasi Management and it was recommended that a continuous on-line monitoring system be implemented on all mill gearsets.

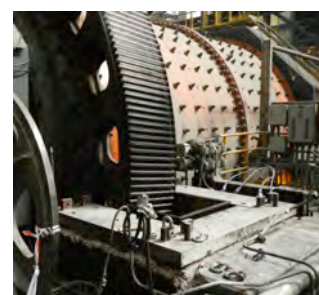
Site personnel reported cracks under the pinion base pedestal. The failure of the grouting and hold-down bolts on the 'B' drive of the Ball Mill is likely to be the result of the reduction in clamping force due to the loosening of the hold-down bolts. The misaligned drive and vibration levels may have further contributed to propagation of the crack. A Boughey Pty Ltd recommended that periodic bolt tightness checks be undertaken on all drive train components, especially the pinion baseplate and housing hold-down bolts.
