A Boughey Pty Ltd at Collahuasi Mine - Chile

Ball Mill Failures

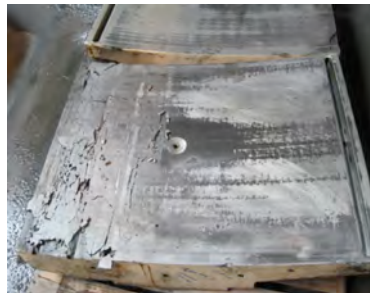
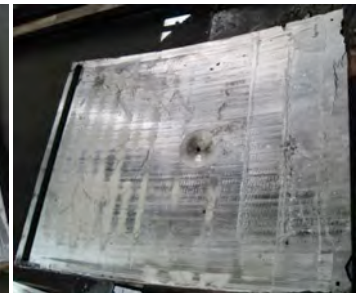
Damage to the main support bearing pads was evident on both the feed and discharge ends of the mill, with catastrophic failure of one pad observed on the discharge end bearing. There was a significant amount of cracking in the babbitt, most likely as a result of heat stress (see photos to the right).

The evidence from the failure mode assessment suggests that the failure was primarily the result of a breakdown of the lubricant film due to contamination. There was significant evidence of high levels of contamination in the oil sampling records.

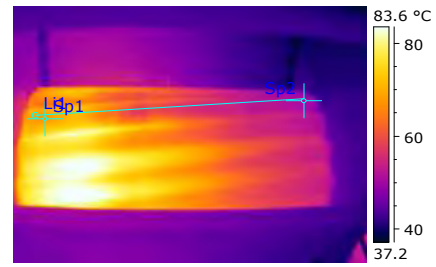
During the site visit, Collahuasi personnel advised that they had identified six broken teeth on the girth gear of the same ball mill. The site advised that there had been a history of failures over a long period of time and that it had been difficult to analyse the actual cause of the failures to date. A number of observations were raised regarding the general operation of the gears, based on the operating parameters. Operating data suggested that damage to the gearset may have been caused by poor alignment and inadequate lubrication.

Temperature measurements (thermography) across the pinion face width indicated that the load was not evenly distributed, but rather concentrated towards one end of the pinion. Gear manufacturers typically recommend a maximum operational temperature differential to be less than 8°C. Recorded differential temperatures have been as high as 24°C across the pinion face width.

Apart from periodical temperature measurements using thermography, no monitoring of the gear temperature had been undertaken. The ball mill gearset lacked a continuous on-line monitoring system to provide good protection and timely feedback against sudden changes in operating conditions. A Boughey Pty Ltd highlighted this to Collahuasi Management and it was recommended that a continuous on-line monitoring system be implemented on all mill gearsets.

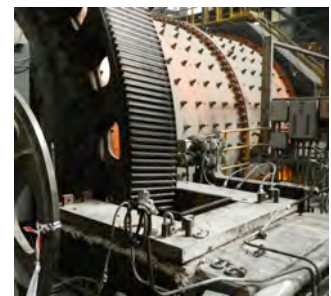
Ball Mill Pinion Baseplate Foundation Crack

Site personnel reported cracks under the pinion base pedestal. The failure of the grouting and hold-down bolts on the 'B' drive of the Ball Mill is likely to be the result of the reduction in clamping force due to the loosening of the hold-down bolts. The misaligned drive and vibration levels may have further contributed to propagation of the crack. A Boughey Pty Ltd recommended that periodic bolt tightness checks be undertaken on all drive train components, especially the pinion baseplate and housing hold-down bolts.

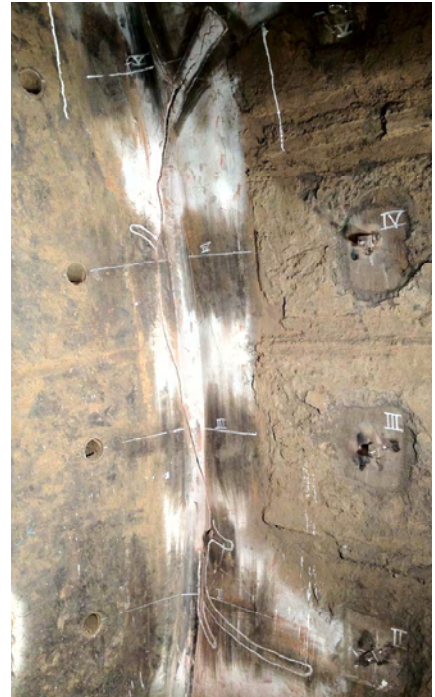
In April 2012, Collahuasi personnel discovered a crack approximately 2 metres in length on the welded joint between the shell and head on the same ball mill that had experienced gearset and pad bearing failures. The crack was detected underneath the riding ring journal of the mill.

A Boughey Pty Ltd was requested to attend site as a matter of urgency to provide technical support and expertise to evaluate the repair options and the relative risks associated with repairing the welded joint. The evaluation resulted in a methodology being developed to repair the crack in-situ.
