A Boughey Pty Ltd at Collahuasi Mine - Chile

Ball Mill Failures

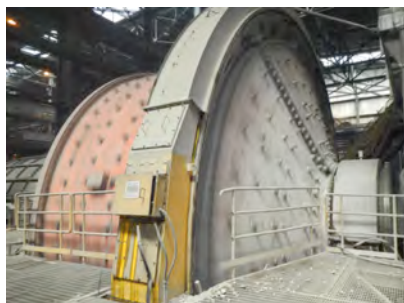
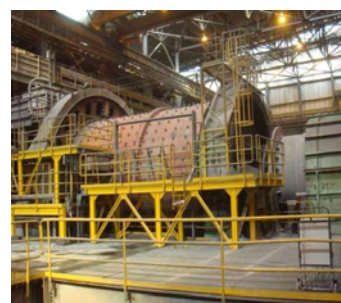
In March 2012, A Boughey Pty Ltd was contracted to inspect and audit all the grinding mills operating at Collahuasi. The mills were inspected whilst in operation and during shutdown conditions. Consideration was given to mechanical, electrical and hydraulic operating aspects of those

components that were accessible during the visit. An inspection and audit report was prepared for the client, encompassing critical parts that needed repair or replacement, as well as recommendations on maintenance and operating process improvements for each mill and its surroundings.
