A Boughey Pty Ltd at Collahuasi Mine - Chile

Ball Mill Failures

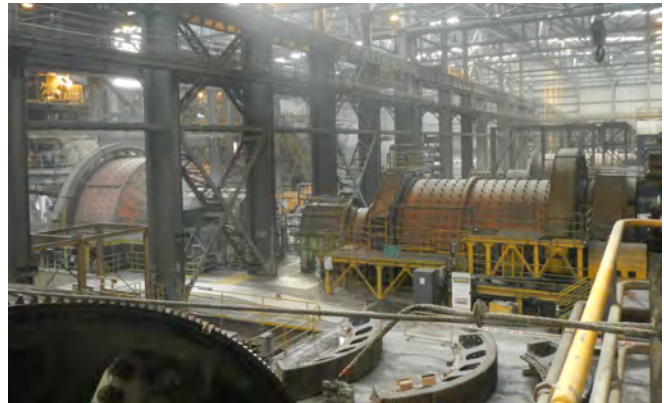
In November 2011, Collahuasi senior management requested the services of A Boughey Pty Ltd to assist in an investigation of a main pad bearing failure that had occurred on one of the ball mills installed at the mine's concentrator plant. During a subsequent site visit in December, the client reported a number of additional failure events on this and another ball mill.

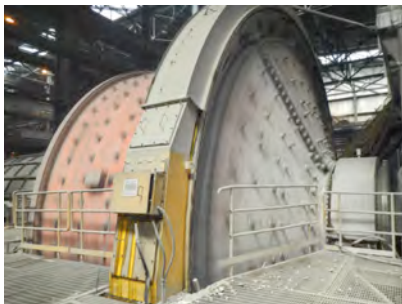
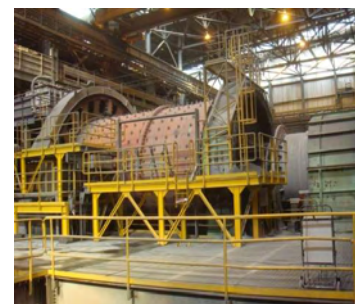
In March 2012, A Boughey Pty Ltd was contracted to inspect and audit all the grinding mills operating at Collahuasi. The mills were inspected whilst in operation and during shutdown conditions. Consideration was given to mechanical, electrical and hydraulic operating aspects of those

components that were accessible during the visit. An inspection and audit report was prepared for the client, encompassing critical parts that needed repair or replacement, as well as recommendations on maintenance and operating process improvements for each mill and its surroundings.
